LITHIUM BATTERIES — WHAT'S THE PROBLEM?

BRANZ

January 2020

Fire and Emergency New Zealand Research Report Number 174

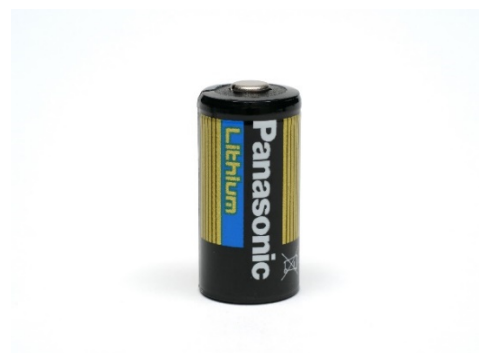
Figure 1. Lithium 'CR2032' Coin Cell

Primary lithium cells are considered hazardous for a number of reasons, they contain a lithium metal anode (which is highly reactive), the electrolyte can be made of flammable organic solvents and they can contain potentially explosive components such as perchlorates (Libona, 2011). Primary lithium cells are generally small and not used in bulk in a single application, for example, a single 'coin' cell is used in a wristwatch. Larger primary lithium cells, such as the CR123A shown in Figure 2, are used in high power applications, such as torches.

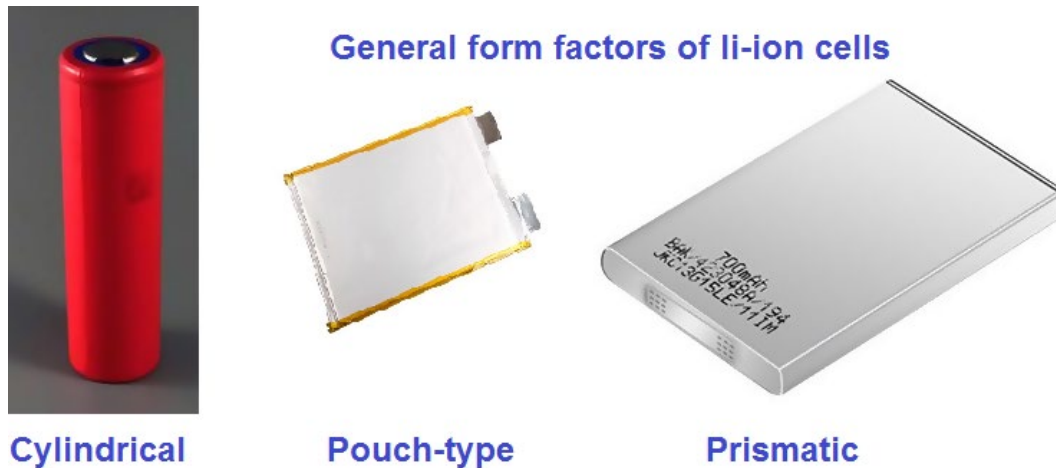
Figure 3. Lithium-Ion Battery Form-Factor

Secondary rechargeable lithium-ion cells use lithium oxides as an electrode, with a lithium-based electrolyte to transport charge between the electrodes during charge and discharge cycles, hence the name lithium-ion cell. They can be customised into almost any size/capacity but are generally cylindrical, pouch or prismatic in form-factor as shown in Figure 3.

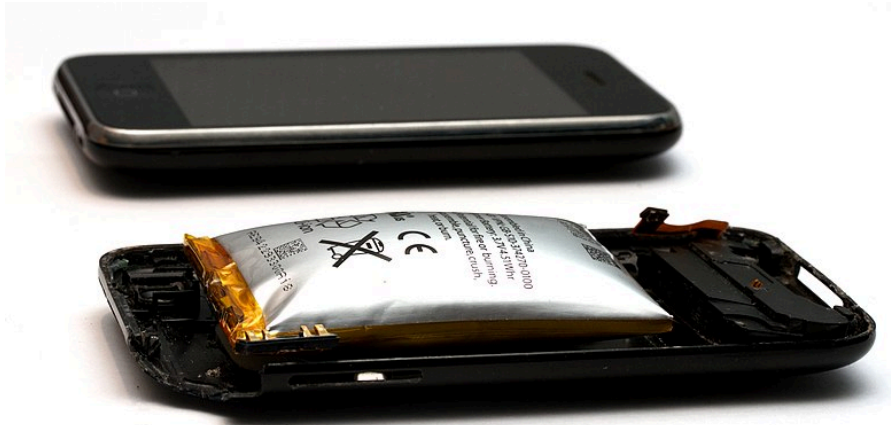
Figure 4. Swollen Pouch Cell

Thermal runaway results from an increasing cell temperature due to either external heating or internal heat generation within the cell. If the temperature continues to rise, the electrolyte will boil, causing an increase in pressure within the cell, as shown in Figure 4. The breakdown of the electrolyte in the cell is irreversible, once a cell undergoes this type of abuse, the cell is damaged permanently and should not be re-used, even if the cause of the overheating is removed.

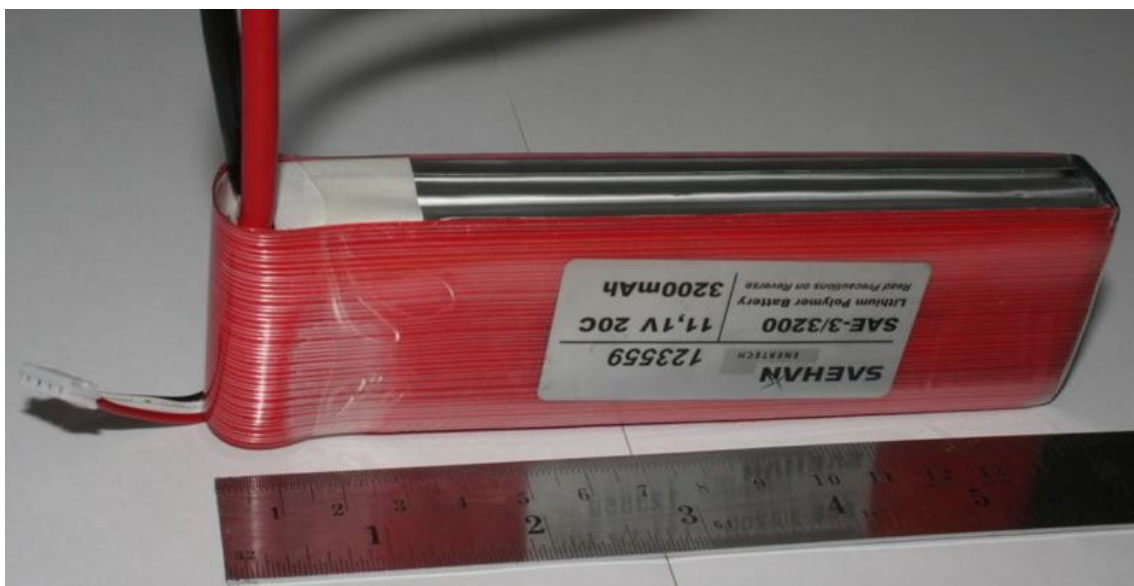
Not all batteries are equipped with a BMS. For example, the battery packs used for model aircraft and many other hobby vehicles do not have a BMS, they are simply cells connected together, in a single package. In the example below, 3 cells are connected in series to produce an output of 11.1 volts, 3.2Ah. Note also the high discharge capacity of 64 A (20C x 3200mAh) but no indication, on the labelling, of what the battery charging current should be.

Figure 5. 3-Cell lithium battery

This type of battery (shown in Figure 5) is commonly used in radio-controlled vehicles and other children's toys and is particularly susceptible to being over-charged. These batteries do not tend to be supplied with a charger specific to the battery, users may purchase multiple batteries and a single generic charger. This can result in different chemistry batteries being plugged in without the appropriate settings being altered in the charger.

Not all chargers support balancing of cells. In Figure 5 at the lower left side of the battery, a balancing lead can be seen. This is connected to the terminals of each cell, so for the 3-cell battery shown, there would be four leads as shown in Figure 6 below.

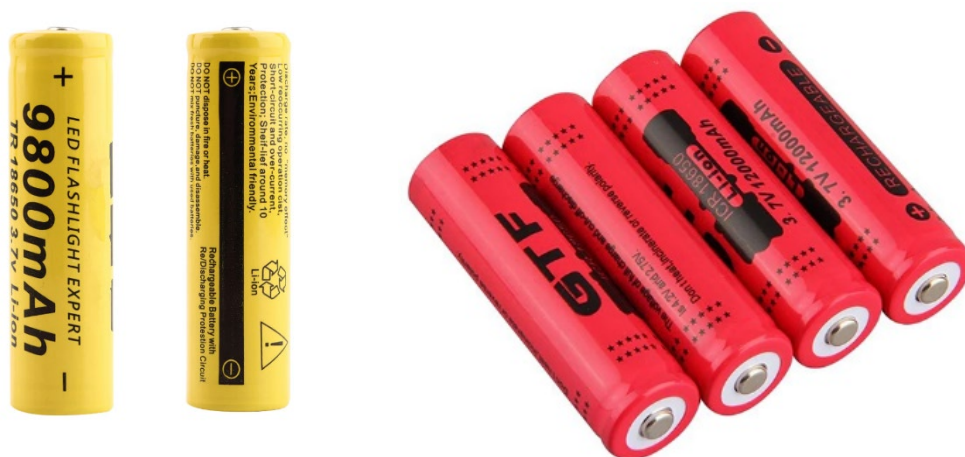
Figure 7. 9800 and 12000 mAh Cells on AliExpress

Some manufacturers are making questionable claims about cell capacity and discharge rate, as shown below in Figure 6. Current limitations on cell chemistry mean that it is not physically possible to fit the energy density claimed into an 18650-size cell but unfortunately, the general public take these claims at face value. With current technology, anything claiming more than 3500-3600 mAh in an 18650-size cell is likely to be unrealistic.

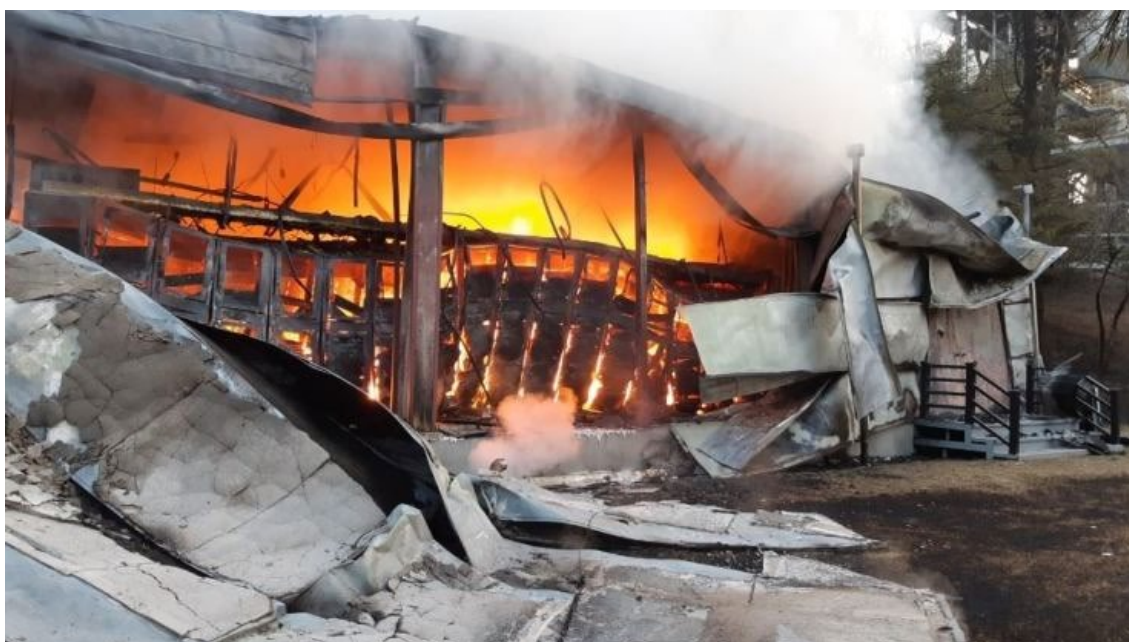
Figure 10. A fire engulfs an ESS at a cement plant in Jecheon, North Chungcheong Province, Korea

In December 2018, an ESS installed at a cement plant in Jecheon caught fire causing \$3.6m USD in damages to the plant. It was the 15th ESS fire in 2018 and occurred as the Korean Ministry of Trade, Industry and Energy were undertaking inspections of all ESS facilities. The installation was setup by LG Chem, one of the top 3 LI cell manufacturers (Hyun-woo, 2018).
